# INVENTORY & SCHEDULE OF CONDITION

## Example HMO Bedroom

| INSPECTION DATE | REPORT REFERENCE |
|---|---|
| 21 August 2026 | INV-REDACTED-EXAMPLE |

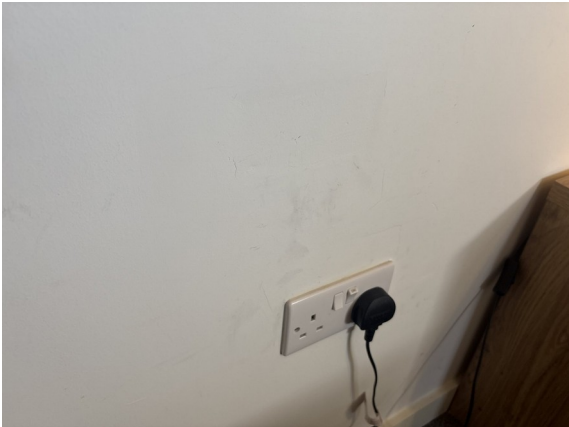
| Room 5 | Description | Condition at Check-In | Condition at Check-Out |
|---|---|---|---|
| <b>Walls</b> | Painted – matt white, with one wall (behind bedhead) in a dark teal matt finish | Good (some marks)<br><b>Photo references:</b><br>R5-02–R5-07, R5-18–R5-19, R5-27–R5-29 | |

**R5-02 | Wall and electrical socket - condition detail**  
Photographed 21 August 2026 at 15:33

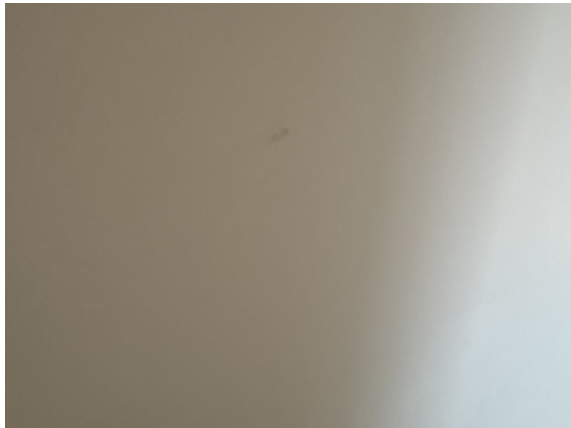
**R5-03 | Wall finish - condition detail**  
Photographed 21 August 2026 at 15:33

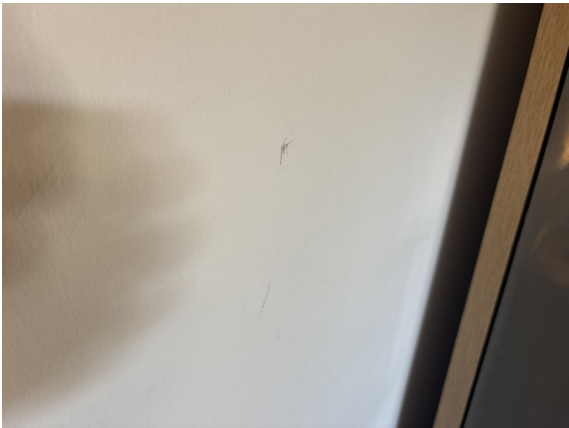
**R5-04 | Wall finish - minor mark detail**  
Photographed 21 August 2026 at 15:34

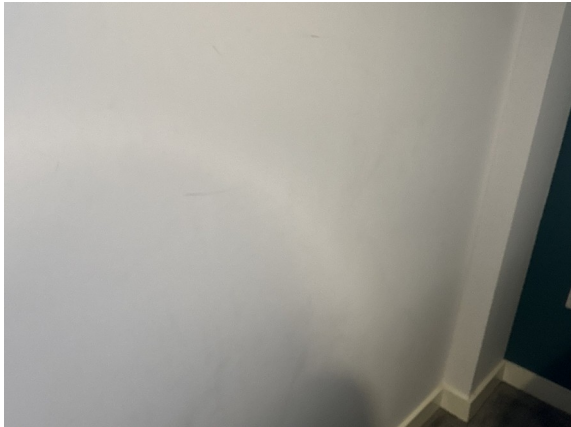
**R5-06 | Wall corner - condition detail**  
Photographed 21 August 2026 at 15:34

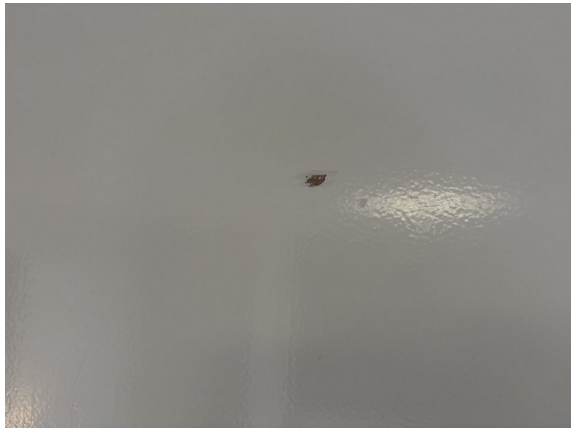
**R5-07 | Paint chip on outside of en-suite door**  
Photographed 21 August 2026 at 15:34

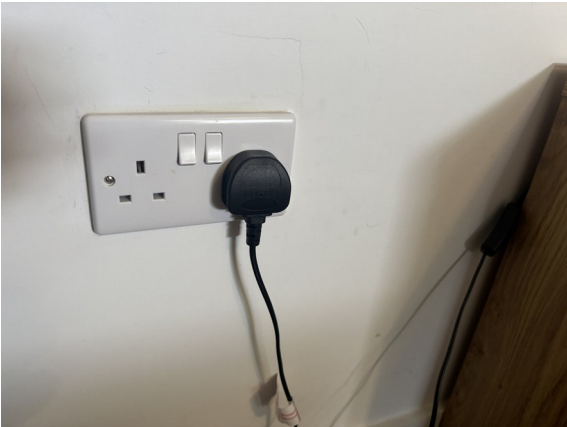
**R5-29 | Double electrical socket and adjacent wall mark**  
Photographed 21 August 2026 at 15:44

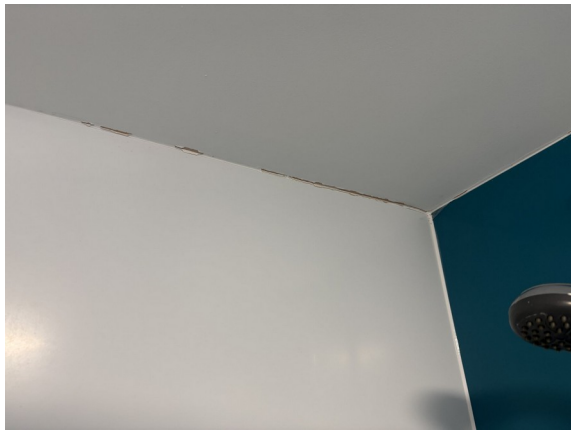
| Room 5 En-Suite | Description | Condition at Check-In | Condition at Check-Out |
|---|---|---|---|
| Walls | Painted – satin white, with one wall in satin teal | Good (in a couple of places on the ceiling corners, the sealant has curled away taking the paintwork with it)<br><b>Photo references:</b><br>ES-01, ES-11,<br>ES-13 | |

**ES-11 | Sealant and paintwork at ceiling corner**  
Photographed 21 August 2026 at 15:43

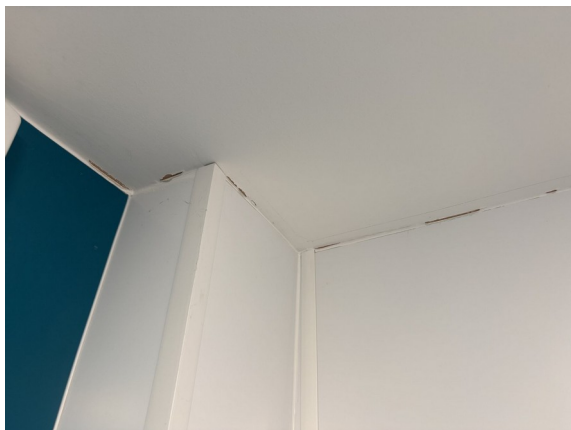
**ES-13 | Separate area of lifted sealant and paintwork at wall/ceiling corner**  
Photographed 21 August 2026 at 15:43

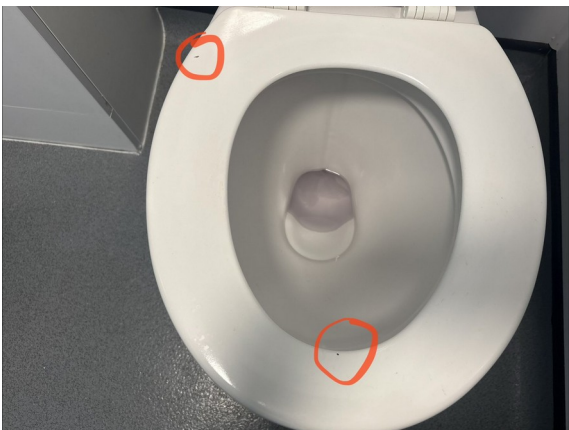
| Room 5 En-Suite | Description | Condition at Check-In | Condition at Check-Out |
|---|---|---|---|
| Toilet | White enamel, with matching plastic seat and lid | Good (some small paint chips on the seat)<br><b>Photo references:</b><br>ES-02-ES-04,<br>ES-14 | |

**ES-14 | Toilet seat - paint-chip condition details**  
Photographed 21 August 2026 at 16:11
